## Preliminary Report

**Air India's B787-8 aircraft bearing registration VT-ANB  
at Ahmedabad on 12 June 2025**

Aircraft Accident Investigation Bureau

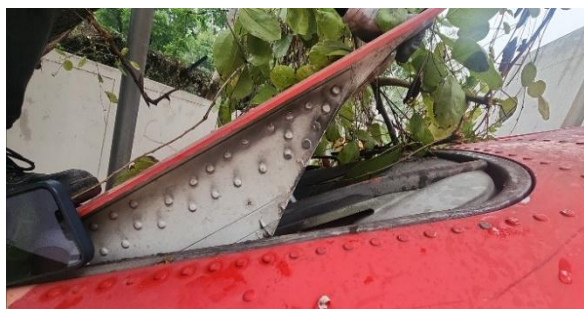
Figure 10 APU Air Inlet Door

After the tail section was brought down, the APU was inspected and found intact inside the APU compartment. The APU air inlet door (*fig. 10*), which was intact, was found open. The fuselage fragmented and sustained thermal damage as it traveled along the northwest faces of Buildings C, D, E, and F with the furthest debris observed at about 765 feet southwest from the initial point of contact with building A. The flight deck area and windshield support structure came to rest at about 650 feet southwest from the initial point of contact with Building A.

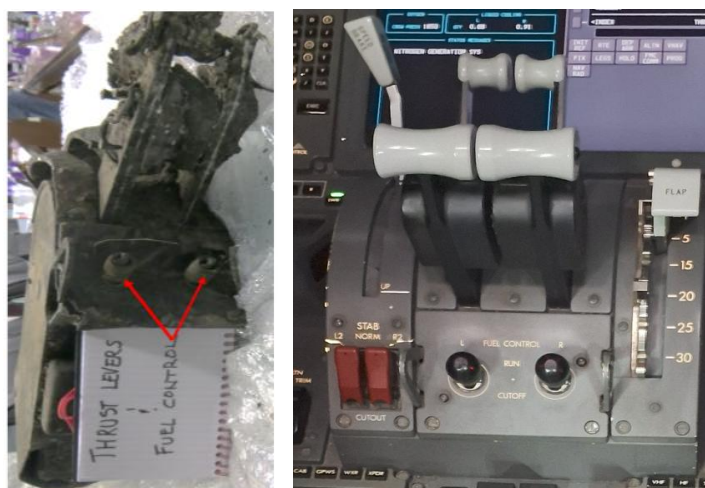
Figure 13 Thrust Lever Quadrant & Fuel Control Switch

The thrust lever quadrant sustained significant thermal damage. Both thrust levers were found near the aft (idle) position. However, the EAFR data revealed that the thrust levers remained forward (takeoff thrust) until the impact. Both fuel control switch were found in the “RUN” position. (*fig.13*) The reverser levers were bent but were in the “stowed” position. The wiring from the TO/GA switches and autothrottle disconnect switches were visible, but heavily damaged.

The aircraft achieved the maximum recorded airspeed of 180 Knots IAS at about 08:08:42 UTC and immediately thereafter, the Engine 1 and Engine 2 fuel cutoff switches transitioned from RUN to CUTOFF position one after another with a time gap of 01 sec. The Engine N1 and N2 began to decrease from their take-off values as the fuel supply to the engines was cut off.
